INDOOR AIR QUALITY ASSESSMENT

Hale Middle School 55 Hartley Road Stow, MA

Prepared by:
Massachusetts Department of Public Health
Center for Environmental Health
Bureau of Environmental Health Assessment
Emergency Response/Indoor Air Quality Program
October 2004

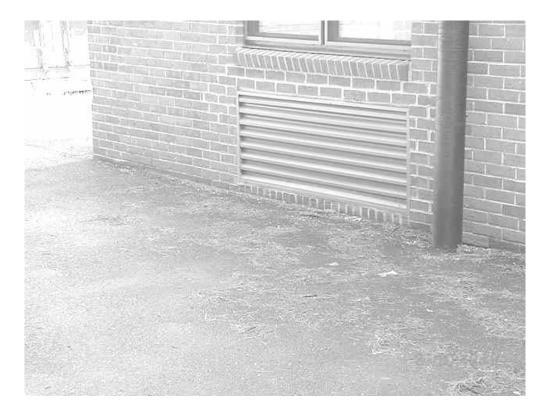
Univent Air Intake

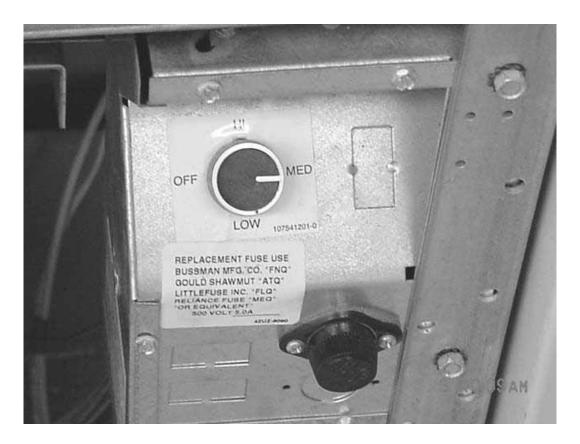
Univent Fan Speed Control

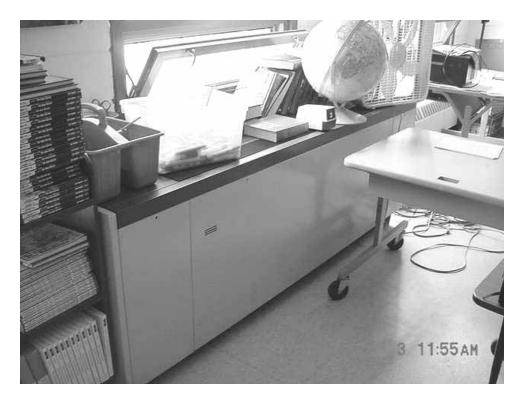
Classroom Items on Univent Air Diffuser

- 3. Inspect exhaust motors and belts for proper function. Repair and replace as necessary.
- 4. Remove all blockages from univents and exhaust vents to ensure adequate airflow.

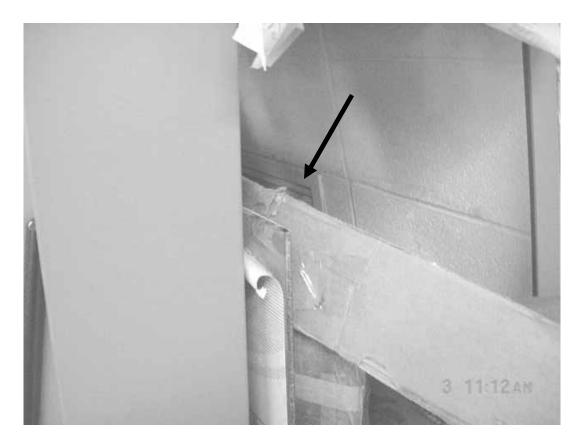
weakly in several areas surveyed (Table 1), indicating that motors were deactivated or non-functional. Exhaust vents were obstructed in some areas (Picture 4). As with the univents, exhaust vents must be activated and remain free of obstructions in order to function as designed. Without sufficient supply and exhaust ventilation, environmental pollutants can build up, leading to indoor air quality complaints.

Obstructed Exhaust Vent in Tech. Ed Room

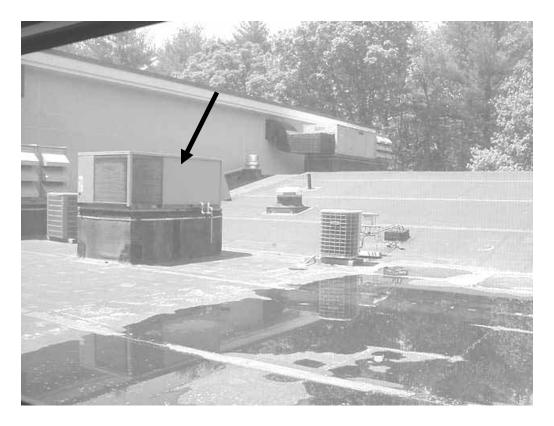
Mechanical ventilation for common areas (gymnasium, auditorium, cafeteria, etc) is provided by air-handling units (AHUs), which are located on the roof (Picture 5) or in mechanical rooms. Air is provided through wall or ceiling-mounted vents and ducted back to AHUs via ceiling or wall-mounted return grills. These systems were operating during the assessment.

Rooftop AHU

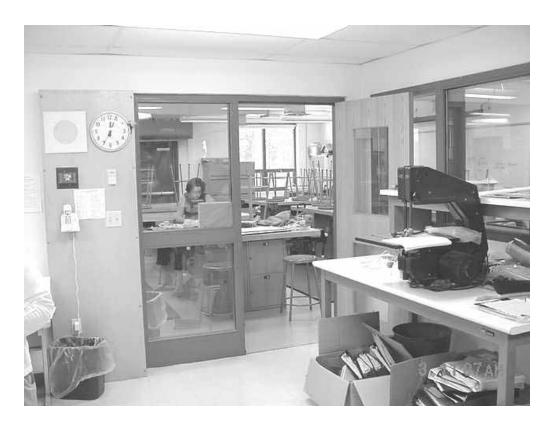
Open Door between Computer Room and Technology Education Room

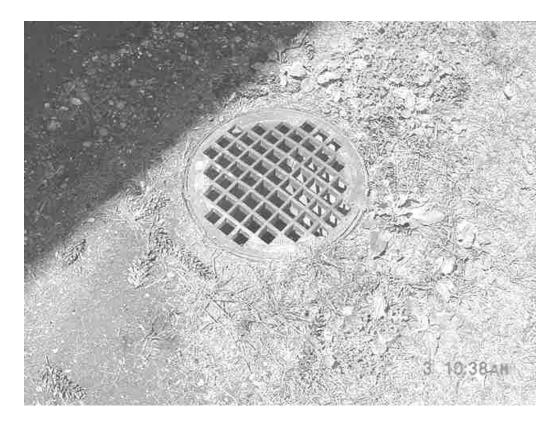
- Installed a drainage system and catch basin (Picture 7);
- Re-graded the land outside of this area of the building to direct water toward the drain; and

Drain Installed Outside of Corner Classroom 102

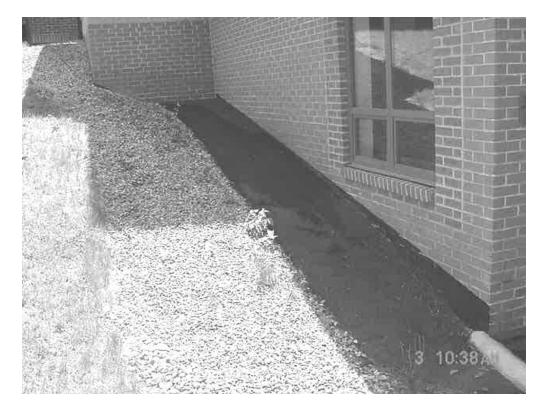
• Installed a tarmac against the exterior wall to facilitate water flow toward the drain (Picture 8).

Grading of Land and Tarmac Installed Outside Corner Classroom 102

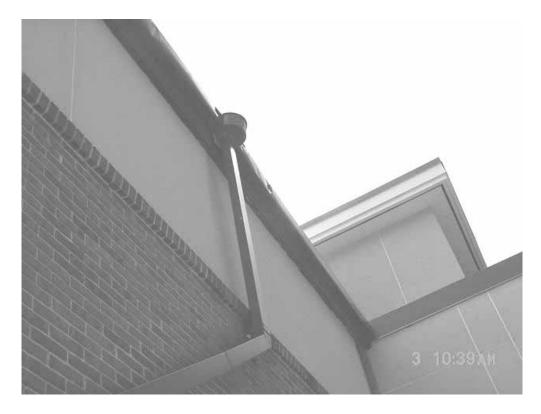
The building is equipped with gutters and downspouts to drain rainwater away from the building. The gutter system in the rear of the building was damaged, causing water to splash against the building (Pictures 9 and 10). Excessive exposure of exterior brickwork to water can result in damage over time. During winter weather, the freezing

Damaged Gutter/Downspout outside Classroom 102

- 10. Repair gutter system to prevent backsplash against the building.
- 11. Consider placing dehumidifiers on sink countertops to allow drainage directly into sinks. Clean and maintain dehumidifiers as per the manufactures instructions.

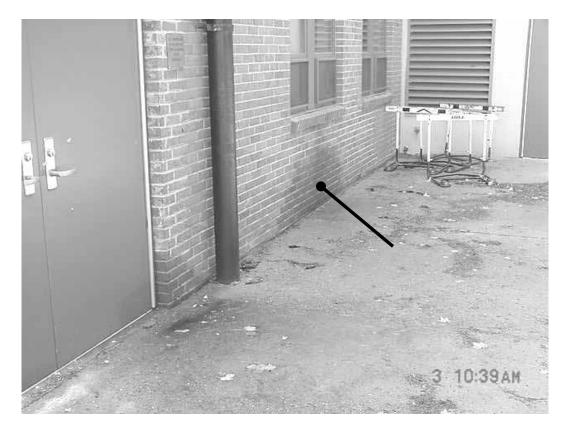
and thawing of moisture in bricks can accelerate the deterioration of brickwork. Damaged brickwork can result in water intrusion.

Characteristic Backsplash Stain against Building

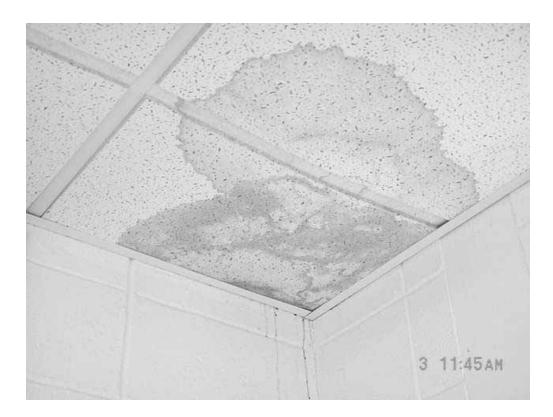
Active roof leaks were reported and water damaged ceiling tiles were observed in several areas of the building (Table 1/Picture 11). At the time of the assessment, school officials reported that they were working with a roofing contractor to repair faulty flashing. Water-damaged ceiling tiles can provide a source of mold and should be replaced after a water leak is discovered and repaired. In addition, several roof drains were noted to be clogged with pine needles and debris, which can lead to water pooling and potential roof leaks (Picture 12). The US Environmental Protection Agency (US EPA) and the American Conference of Governmental Industrial Hygienists (ACGIH) recommends that porous materials be dried with fans and heating within 24 to 48 hours of becoming wet (US EPA, 2001; ACGIH, 1989). If porous materials are not dried within this time frame, mold growth may occur. Water-damaged porous materials cannot be adequately cleaned to remove mold growth. The application of a mildewcide to moldy porous materials is not recommended.

Water Damaged Ceiling Tiles

- 9. Continue with plans to make roof/flashing repairs. Once leaks are repaired, replace water damaged ceiling tiles. Examine the area above and around these areas for mold growth. Disinfect areas of water leaks with an appropriate antimicrobial.

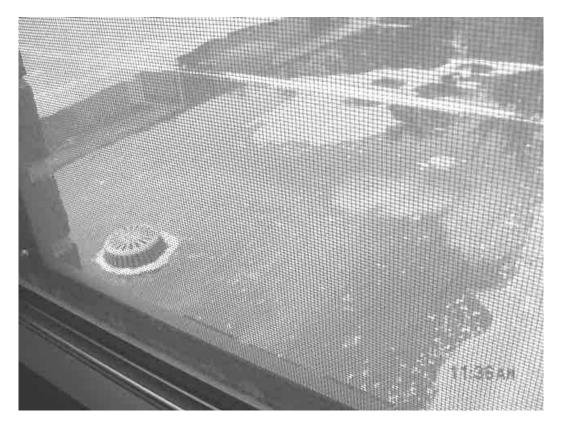
Clogged Roof Drain and Water Pooling on Lower Roof

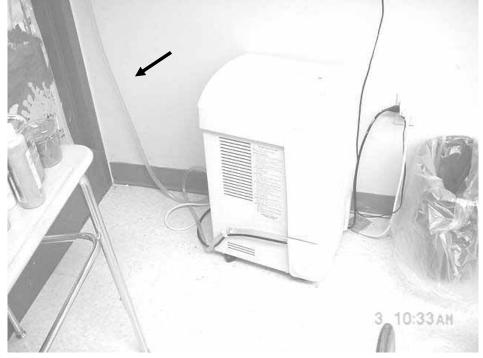
Dehumidifiers were in operation in lower level classrooms. To provide continuous drainage and prevent standing water, the reservoirs of dehumidifiers were being mechanically pumped into the slop-sink in the custodial closet. However, in order for the water to drain into the slop-sink it has to be pumped vertically 8-10 feet above the ceiling tile system, through the hallway and down into the custodial closet (Pictures 13-15). Although this system appeared to be working in the majority of areas (the dehumidifier in the language room was not operating), the opportunity for mechanical pumps to malfunction exists. Most of the lower level classrooms are equipped with sinks. BEHA

Dehumidifier in Lower Level Classroom with Pump and Drainage Vertical Tube

staff recommended that dehumidifiers be stationed on sink countertops to allow hoses to drain directly into sinks.

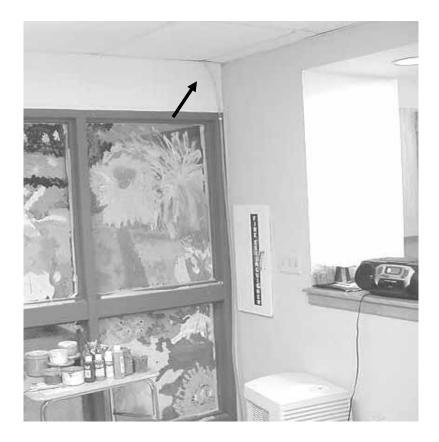
Dehumidifier Drainage Tube Into/Over Ceiling Tile System

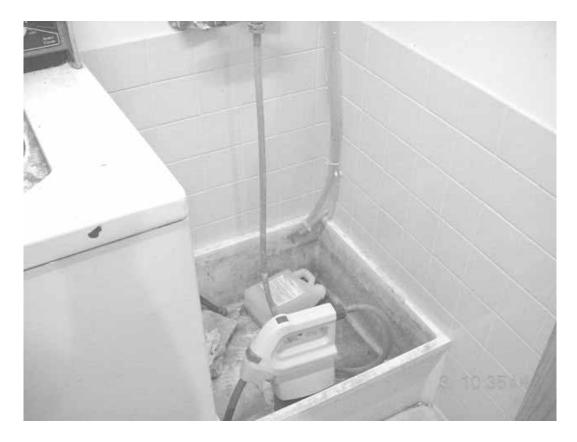
Dehumidifier Drainage Tubes Draining into Slop-Sink in Custodial Closet

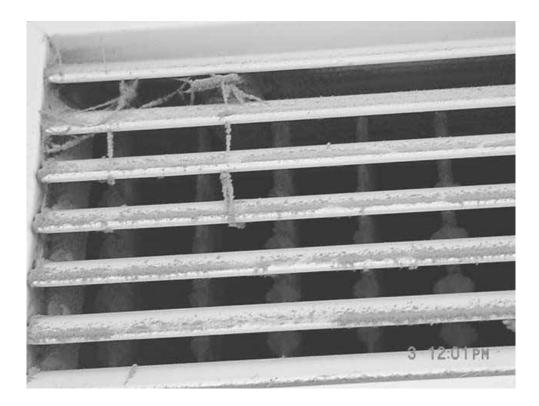
Several other conditions that can affect indoor air quality were seen during the assessment. Accumulated dust was observed on classroom exhaust vents (Picture 16). Exhaust vents should be cleaned periodically to avoid aerosolizing accumulated dust. Also of note was the amount of materials stored inside some classrooms (Picture 17). Items were observed on windowsills, tabletops, counters and bookcases. The large number of items stored provides a source for dusts to accumulate and make it difficult for custodial staff to clean. Airborne dust can be irritating to eyes, nose and respiratory tract. Items should be relocated and/or be cleaned periodically to avoid excessive dust build up.

Accumulated Dust Build-up on Exhaust/Return Vent

- 13. Clean exhaust/return vents periodically to prevent excessive dust build-up.
- 14. Clean/change filters for portable air purifiers as per manufacturer's instructions or more frequently if needed.

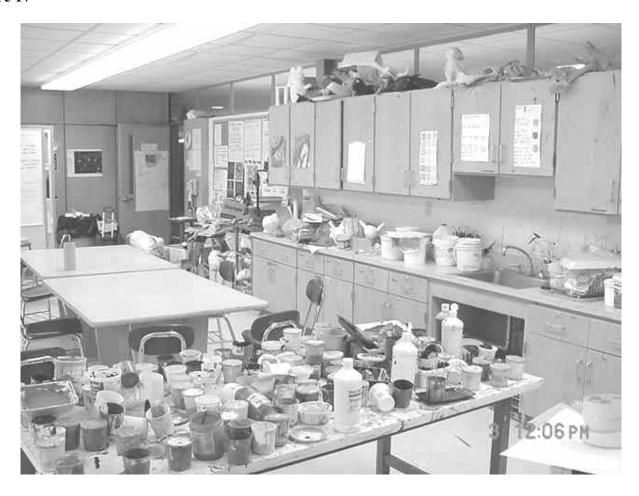
Accumulated Items on Flat Surfaces in Art Classroom

- 12. Relocate or consider reducing the amount of materials stored in classrooms to allow for more thorough cleaning. Clean items regularly with a wet cloth or sponge to prevent excessive dust build-up.
